# Blair Hill Wind Farm

## Technical Appendix 10.5

### Peat Landslide Hazard & Risk Assessment

Author	ITPEnergised
Date	November 2024
Ref	6389

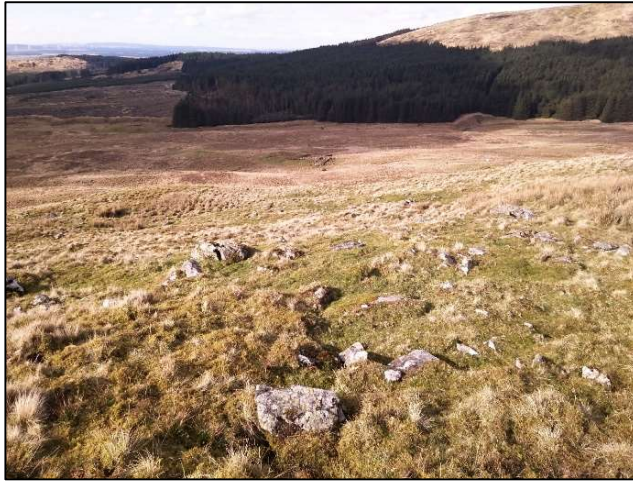
### Photograph 3-2 General views across the site, showing outcropping rock
