Project Title: Blair Hill Wind Farm Peat Survey
Project Code: 6389/2399/4466
Annex 1: Site Photographs

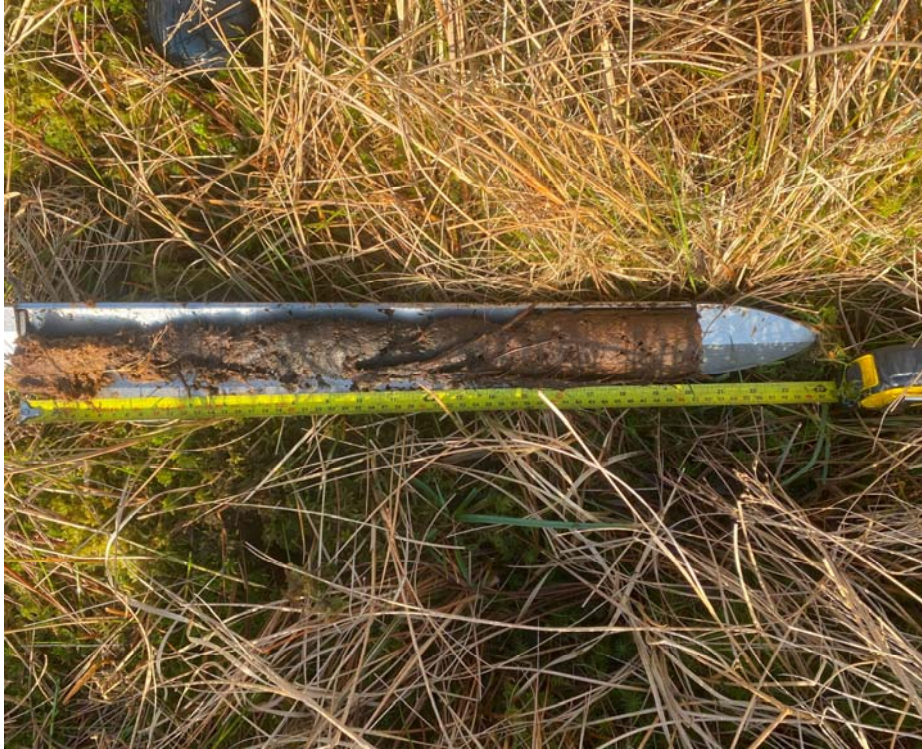
| ID: | Photo 1 | Von Post Classification: | H2 |

| Location: | 241791, 572936 | Underlying Substrate: | N/A |
| Description: | Auger Location 1 | Logged By: | BN / AD |
| Depth (m): | 0 – 0.5 | Date: | 12/03/2024 |

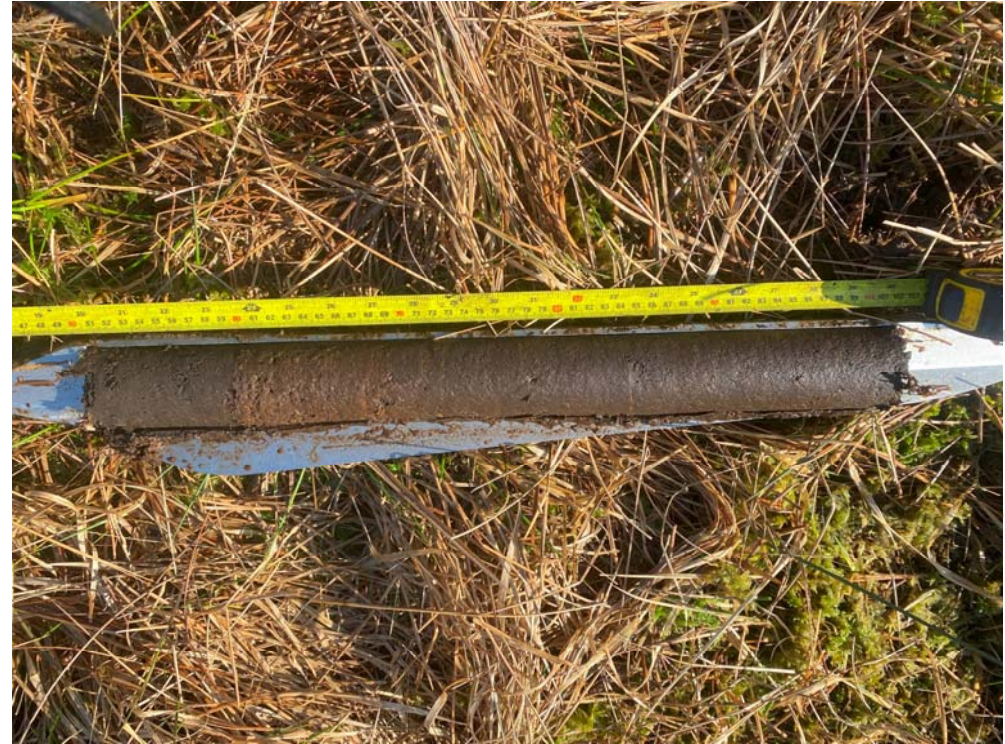
| ID: | Photo 2 | Von Post Classification: | H2/H3 |

| Location: | 241791, 572936 | Underlying Substrate: | N/A |
| Description: | Auger Location 1 | Logged By: | BN / AD |
| Depth (m): | 0.5-1.0 | Date: | 12/03/2024 |

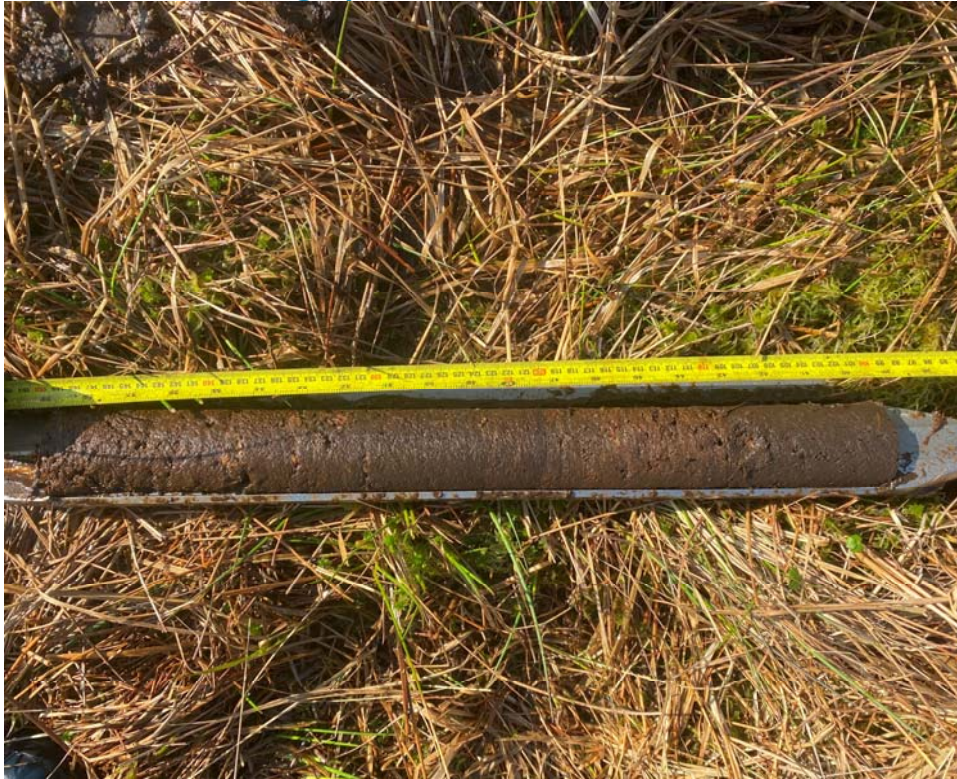
| ID: | Photo 3 | Von Post Classification: | H2/H3 |

| Location: | 241791, 572936 | Underlying Substrate: | N/A |
| Description: | Auger Location 1 | Logged By: | BN / AD |
| Depth (m): | 1.0 - 1.5 | Date: | 12/03/2024 |

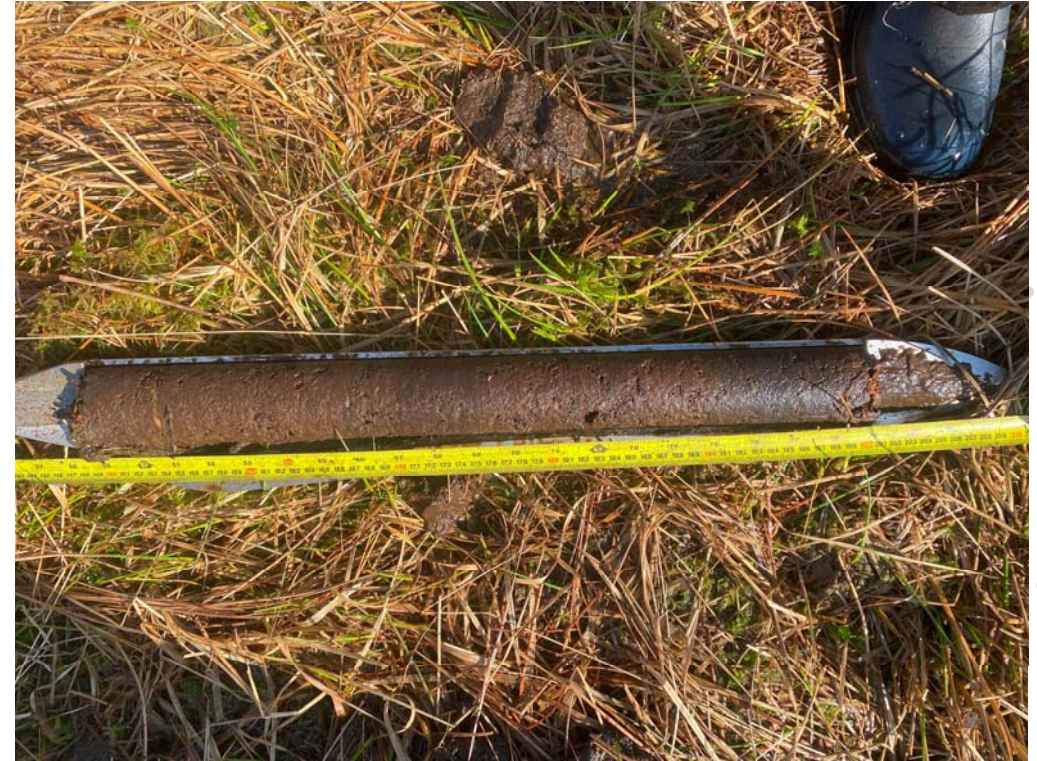
| ID: | Photo 4 | Von Post Classification: | H3 |

| Location: | 241791, 572936 | Underlying Substrate: | N/A |
| Description: | Auger Location 1 | Logged By: | BN / AD |
| Depth (m): | 1.5 – 2.0 | Date: | 12/03/2024 |

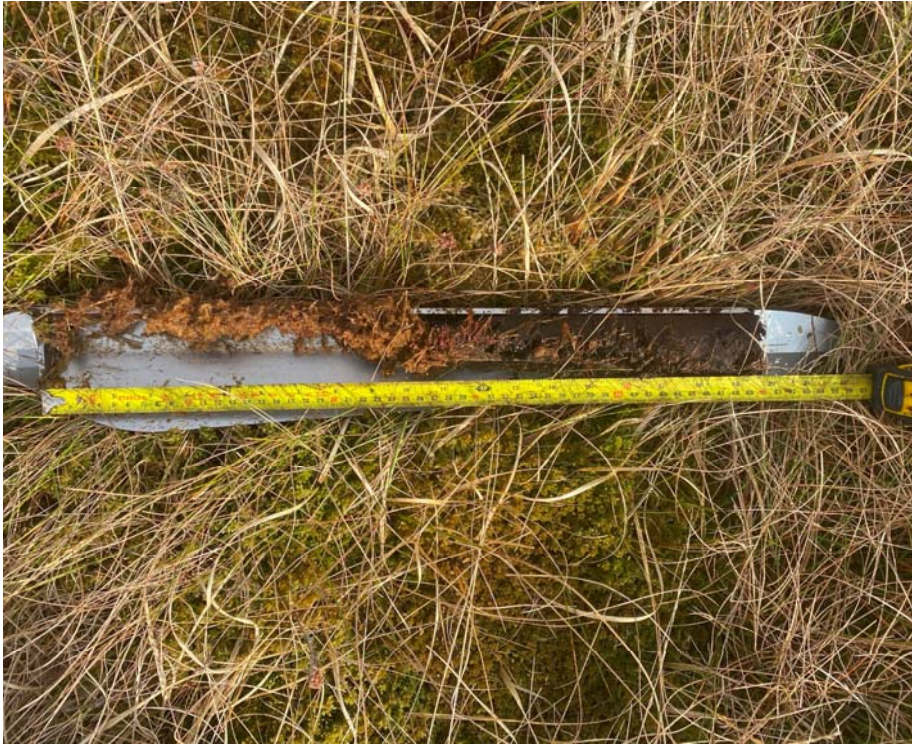
| ID: | Photo 1 | Von Post Classification: | H1 |

| Location: | 242346, 572964 | Underlying Substrate: | N/A |
| Description: | Auger Location 2 | Logged By: | BN / AD |
| Depth (m): | 0.0 – 0.5 | Date: | 12/03/2024 |

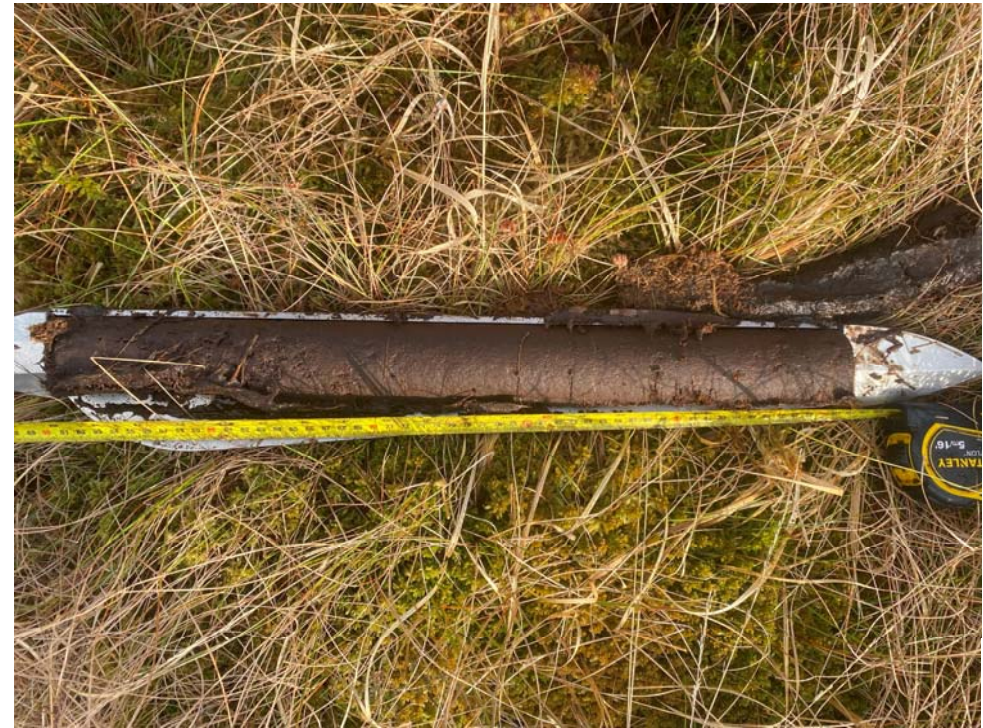
| ID: | Photo 2 | Von Post Classification: | HH2/H3 |

| Location: | 242346, 572964 | Underlying Substrate: | N/A |
| Description: | Auger Location 2 | Logged By: | BN / AD |
| Depth (m): | 0.5 – 1.0 | Date: | 12/03/2024 |

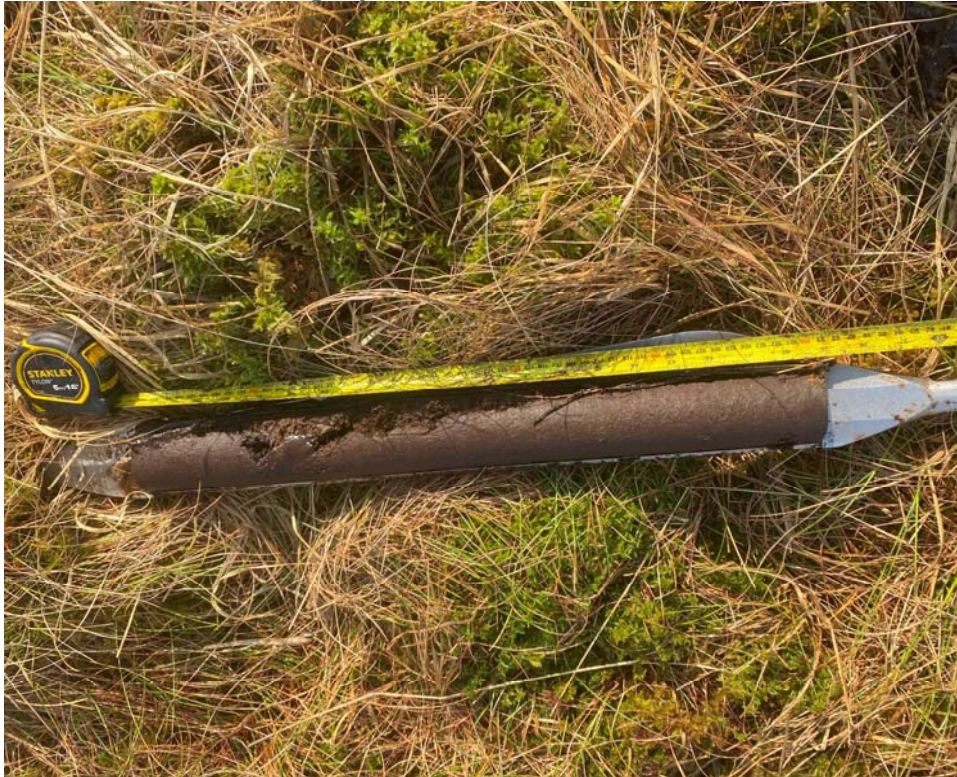
| ID: | Photo 3 | Von Post Classification: | H3 |

| Location: | 242346, 572964 | Underlying Substrate: | N/A |
| Description: | Auger Location 2 | Logged By: | BN / AD |
| Depth (m): | 1.0 – 1.5 | Date: | 12/03/2024 |

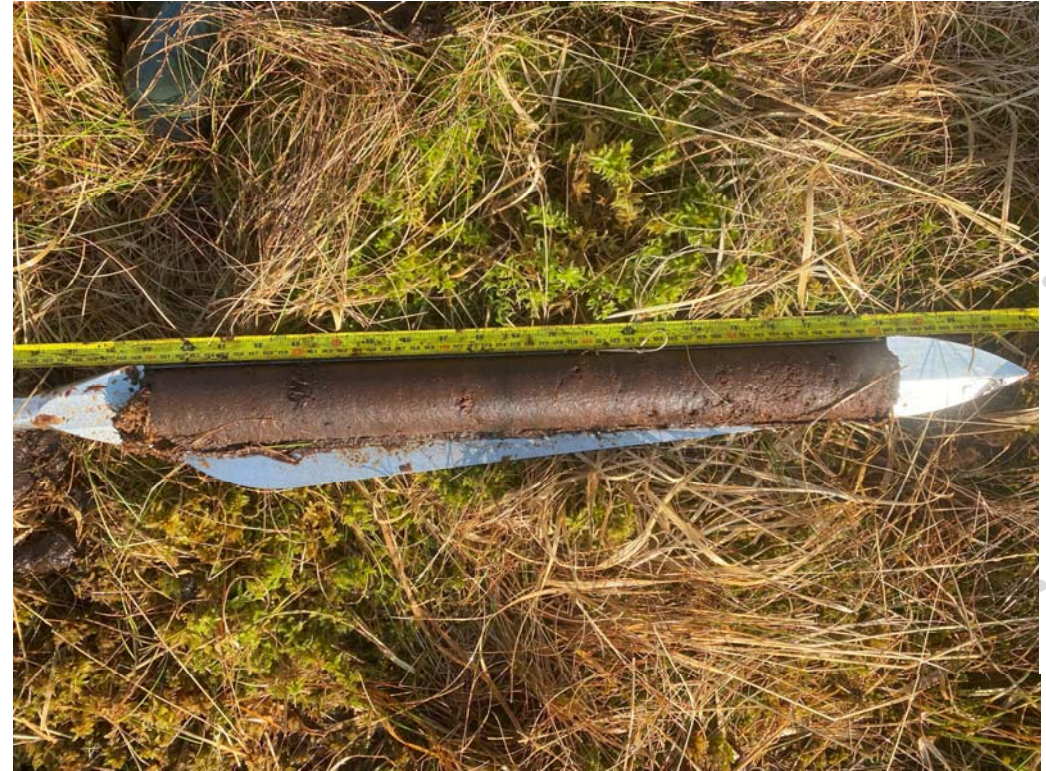
| ID: | Photo 4 | Von Post Classification: | H3/H4 |

| Location: | 242346, 572964 | Underlying Substrate: | N/A |
| Description: | Auger Location 2 | Logged By: | BN / AD |
| Depth (m): | 1.5 – 2.0 | Date: | 12/03/2024 |

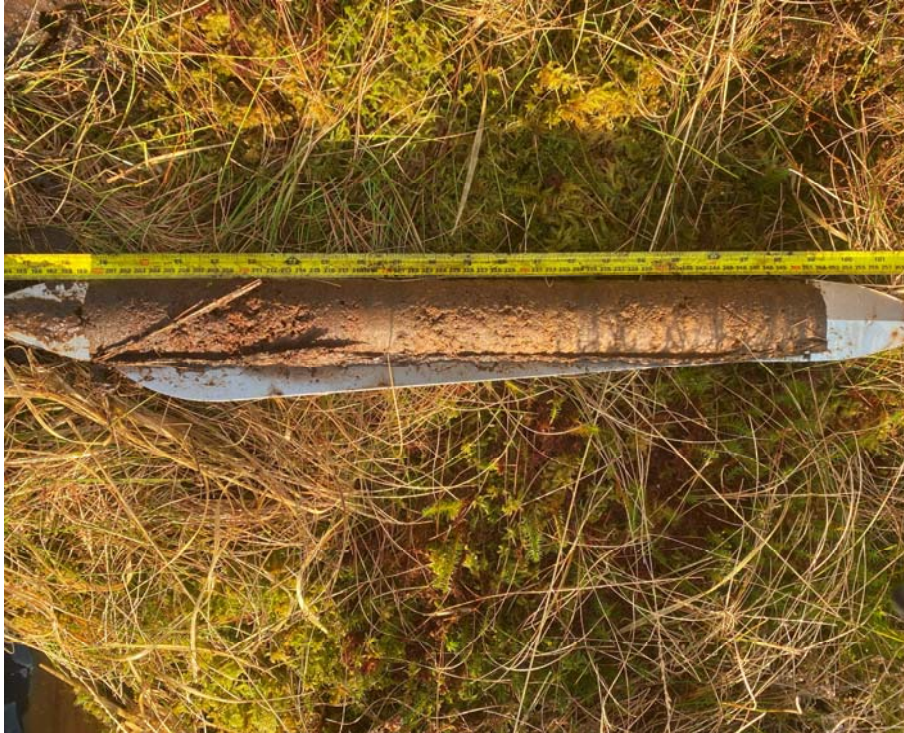
| ID: | Photo 5 | Von Post Classification: | H3/H4 |

| Location: | 242346, 572964 | Underlying Substrate: | N/A |
| Description: | Auger Location 2 | Logged By: | BN / AD |
| Depth (m): | 2.0 – 2.5 | Date: | 12/03/2024 |

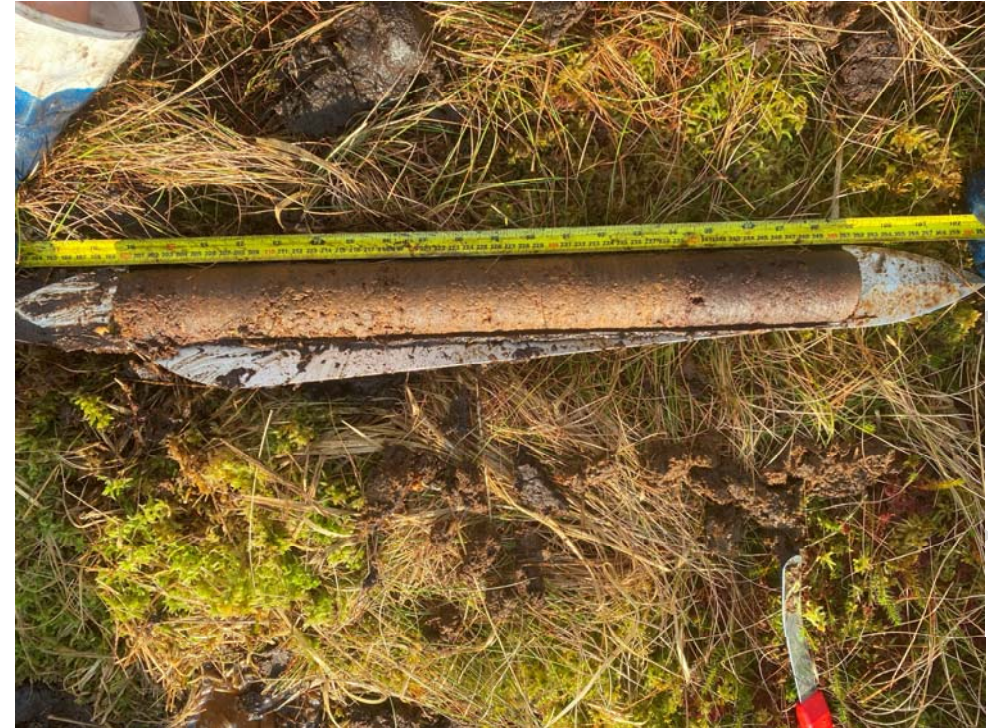
| ID: | Photo 6 | Von Post Classification: | H3/H4 |

| Location: | 242346, 572964 | Underlying Substrate: | N/A |
| Description: | Auger Location 2 | Logged By: | BN / AD |
| Depth (m): | 2.5 – 2.7 | Date: | 12/03/2024 |

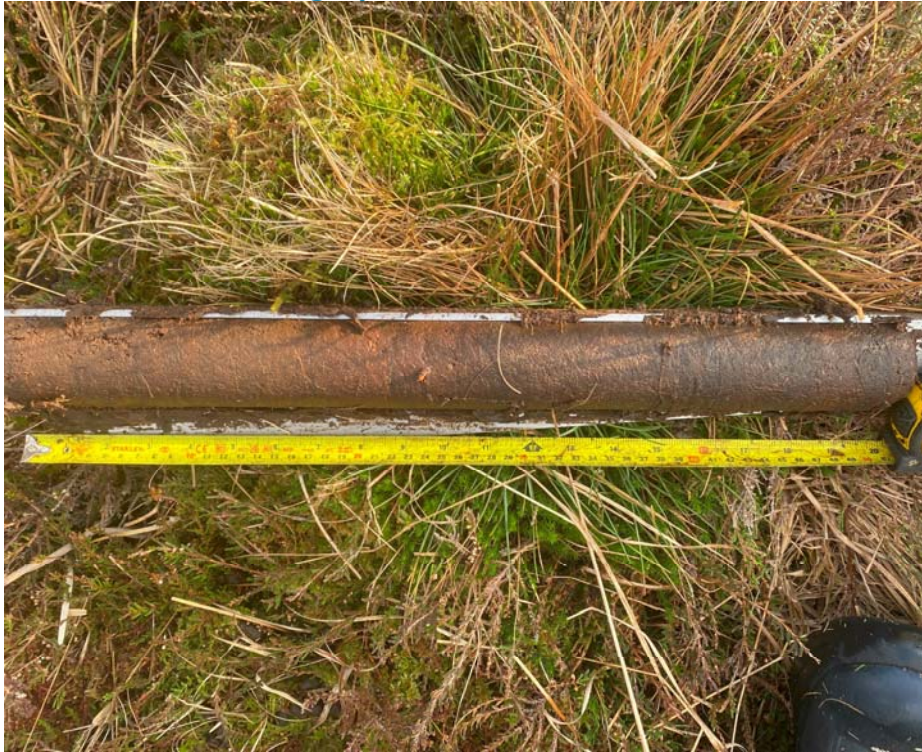
| ID: | Photo 1 | Von Post Classification: | H2 |

| Location: | 242195, 571983 | Underlying Substrate: | N/A |
| Description: | Auger Location 3 | Logged By: | BN / AD |
| Depth (m): | 0-0.5 | Date: | 12/03/2024 |

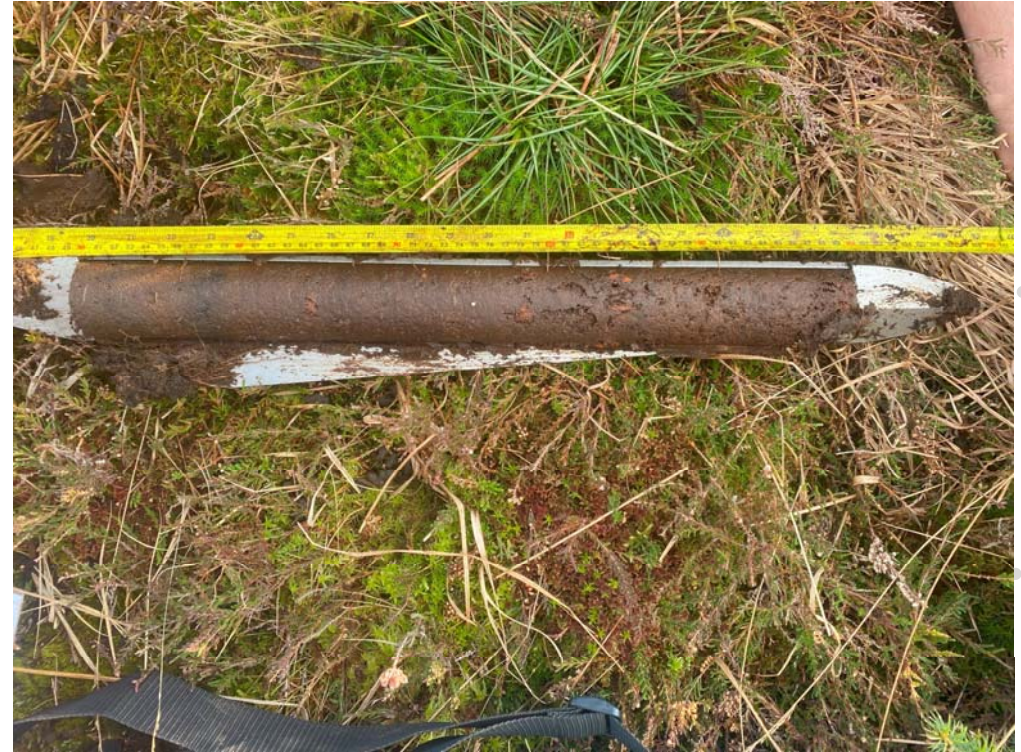
| ID: | Photo 2 | Von Post Classification: | H2/H3 |

| Location: | 242195, 571983 | Underlying Substrate: | N/A |
| Description: | Auger Location 3 | Logged By: | BN / AD |
| Depth (m): | 0.5-1.0 | Date: | 12/03/2024 |

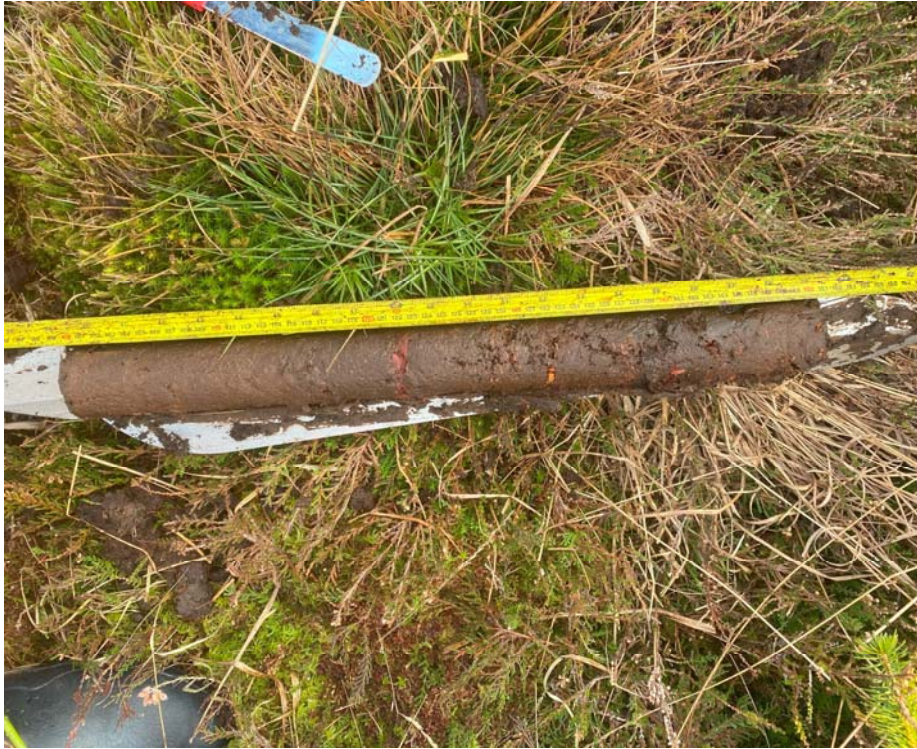
| ID: | Photo 3 | Von Post Classification: | H2/H3 |

| Location: | 242195, 571983 | Underlying Substrate: | N/A |
| Description: | Auger Location 3 | Logged By: | BN / AD |
| Depth (m): | 1.0-1.5 | Date: | 12/03/2024 |

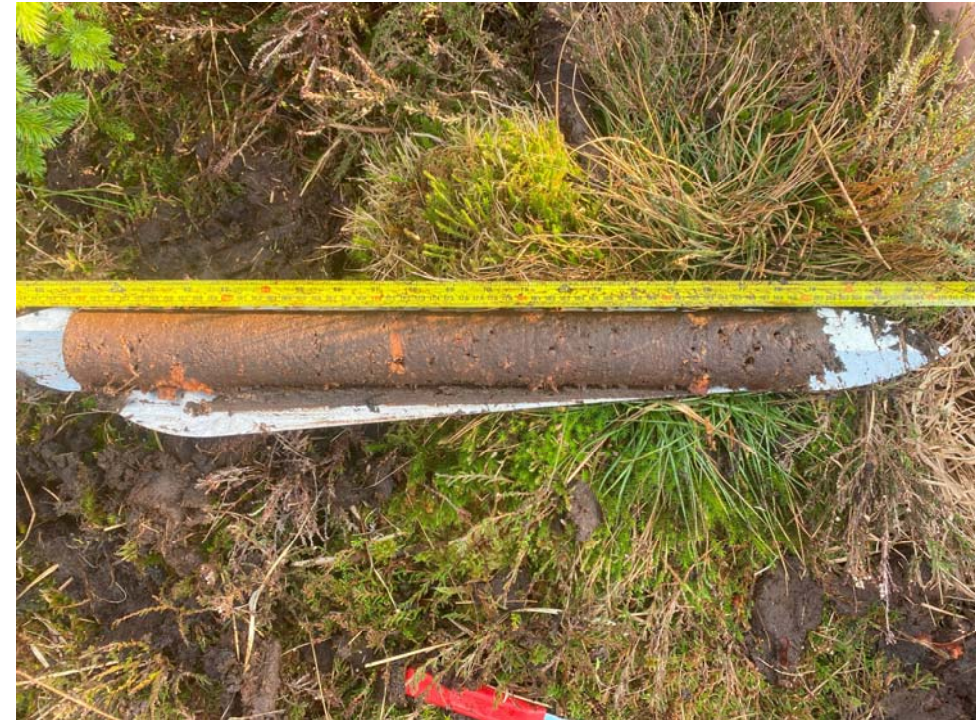
| ID: | Photo 4 | Von Post Classification: | H3 |

| Location: | 242195, 571983 | Underlying Substrate: | N/A |
| Description: | Auger Location 3 | Logged By: | BN / AD |
| Depth (m): | 1.5-2.0 | Date: | 12/03/2024 |

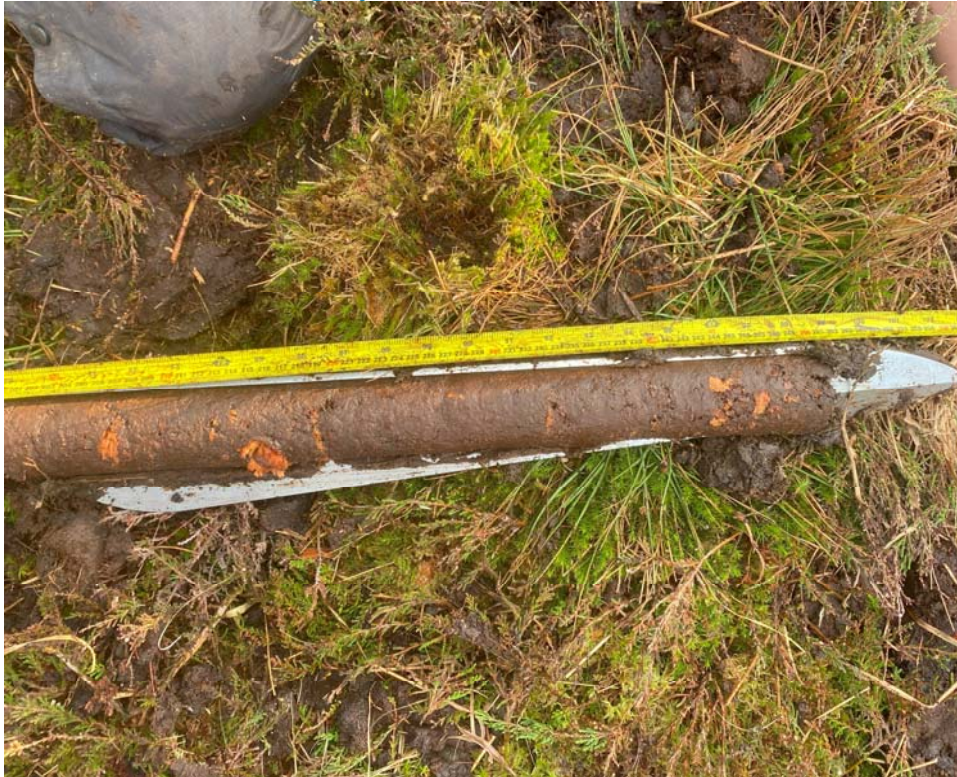
| ID: | Photo 5 | Von Post Classification: | H3/H4 |

| Location: | 242195, 571983 | Underlying Substrate: | N/A |
| Description: | Auger Location 3 | Logged By: | BN / AD |
| Depth (m): | 2.0-2.5 | Date: | 12/03/2024 |
